## Enterprise NVR alpha V5.75.19 Software Release Notes

### Product Description

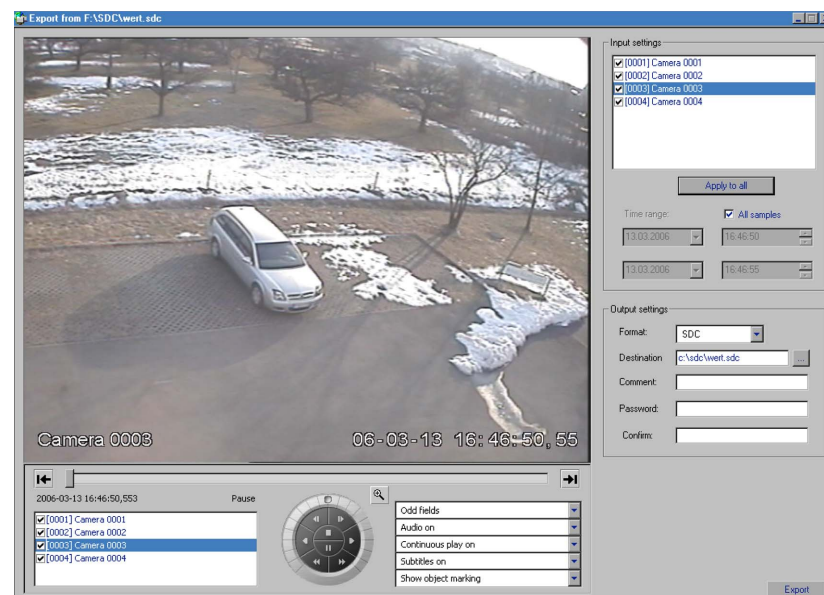
#### Zoom Option in SDC Viewer

Digital zoom option in the SDC Viewer application has been added.
